Pacemaker dysfunction after car accident – a case study.

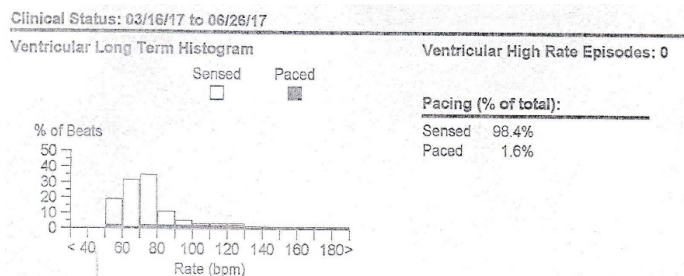
Figure 3. Ventricular long-term histogram records

The ventricular long-term histogram (Figure 3) showed that 98.4% of beats were sensed (only 1.6% paced), predominantly with a rate below 80/min. It means that the patient was pacemaker-independent.

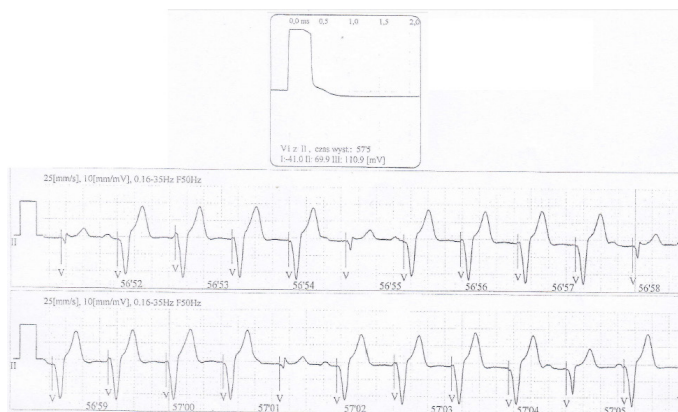
In addition, the device pocket localized in the left sub-clavicular region was normal, without any signs of injury or hematoma. However, during the magnetic Implantable pulse generator (IPG) test, pacing was ineffective, and only sensed beats were recorded. After that, the lower tracking rate (LTR) was set to 90/min in order to check whether the permanent paced rhythm program is accessible. Although the LTR was set to 90/min and a paced rhythm was supposed to be introduced, no pacing beats were recorded – only sensed beats with a rate <90/min. Interestingly, after performing the “Battery and Lead measurement” procedure, paced rhythm with a rate of 90/min was recorded, according to the LTR program. However, after a few minutes pacing episodes became more and more ineffective (Figure 4).

Figure 4. Pacing rhythm HR = 90/min (programmed LTR = 90/min) with alternated pacing episodes.

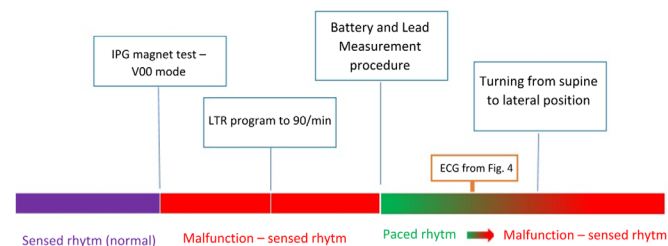
When the patient was turned from a supine to a lateral position, the pacing was lost, and only sensed beats (sinus rhythm, HR = 70/) were recorded. All aforementioned procedures are illustrated in Figure 5.

The opinion from the manufacturer’s support center was that the pacemaker was irreversibly damaged during the

accident and device replacement is warranted. Although the subject was pacemaker independent (Figure 3), the device had been implanted 24 years earlier because of syncope in the course of AV second degree block. Therefore the clinical situation was classified as potentially life-threatening and the patient was transferred to the Accident and Emergency Department and later admitted to the Department of Cardiology. The pacemaker was successfully reimplanted. An X-ray examination and electronic tests during the intervention allowed lead malfunction to be excluded. After the intervention the pacemaker was checked and the patient was discharged the following day.

Figure 4. Procedures executed in order to reveal pacemaker dysfunction.
