Transvenous lead removal with a fragment of a papillary muscle - a silent complication

pacemaker, transvenous lead extraction, complications of lead extraction

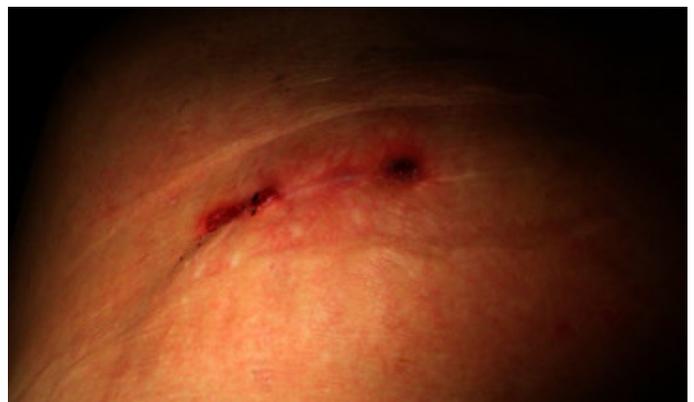
Figure 1 Dehiscence of infected skin with exposure of generator pocket.

76-year-old male patient with ischaemic heart disease, heart failure (NYHA II), chronic kidneys disease, diabetes mellitus type 2 and long history of pacemaker implantation was referred to the Clinic of Cardiac Surgery for pacemaker extraction. He had received his first single-chamber pacemaker implanted in his left infraclavicular area at age 66 owing to bradyarrhythmia, developed during the course of permanent atrial fibrillation associated with Morgagni-Adams-Stokes syndrome. Within two years, the generator pocket was infected as a consequence of recurrent furunculosis, pacemaker was removed leaving leads that deeply grew into the heart tissue. New device was placed in the right side of chest, but subsequent infection (Figure 1.) required extraction once again with the re-implantation of the device on the left side.

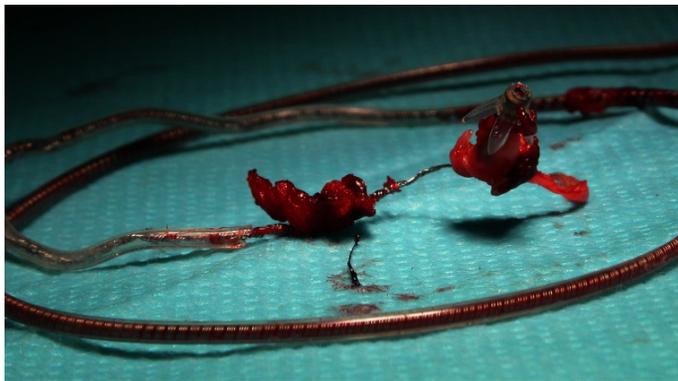
Figure 2 Removed lead with fragment of a papillary muscle (1,5x2cm).

asymptomatic removal of a 3cm-fragment of a papillary muscle attached to the oldest lead (Figure 2. Figure 3), the operation
